MANUFACTURE OF AN ARTIFICIAL HIP JOINT USING A COMPOSITION MATERIAL

Colm Martin *, Brigitte Cornelis **, Michael Jones ** and David Taylor .

Bioengineering Research Centre, Trinity College Dublin.

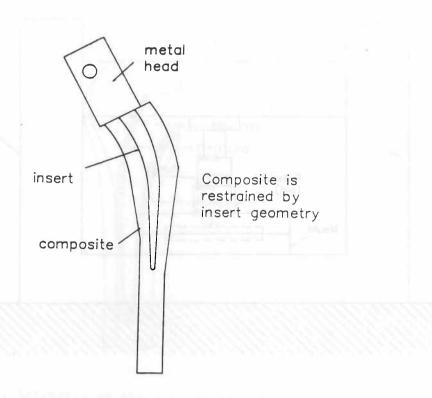
Figure 4. Prototype insert[mark 1]

combination of b.) insert geometry and c.) shrinkage of the composite. Figure 4 illustrates how insert[mark 1] geometry allows shrinkage to occur because of the simple conical, short design. Whereas figure 5 illustrates the restraint imposed on shrinkage due to the longer length of inserts, [mark 2] and [mark 3]. It is proposed that this restraint caused tensile residual stresses, resulting in cracking and complete breakage of the composite at distal regions.

- a.) before shrinkage
- b.) after shrinkage
