# Fatigue Behavior of 3-D Triaxial Braided Composites

Carlos K. Gethers<sup>1</sup>  
Robert L. Saddler<sup>2</sup>  
V. Sarma Avva<sup>3</sup>

<sup>1</sup>Graduate Research Assistant, <sup>2</sup>Adjunct Associate Research Professor, and <sup>3</sup>Professor., Center for Composite Materials Research and Mars Mission Research Center, Department of Mechanical Engineering, North Carolina Agricultural and Technical State University, Greensboro, NC., USA

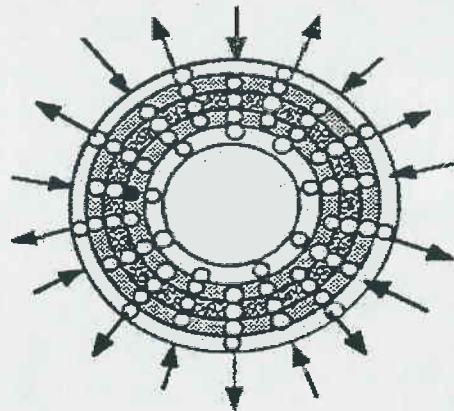
The original position

The first step

The second step

The third step

The fourth step

All preforms were fabricated on a four-step circular braiding machine. The name "four-step" comes from the four distinct carrier movements made by the braider to complete one braiding cycle (see Fig. 3). The braiding machine consists of an elevated bobbin, table of rotating concentric column and carrier rings, pneumatic actuators that alternately power the columns and carriers, and elastic tension control devices (TCDs). This particular braiding machine has 180 braider (moving) carriers and 150 axial (fixed) carriers. Connected to these carriers are elastic bands (TCDs). These bands are used to vary the tension placed on the fiber tows during braiding.

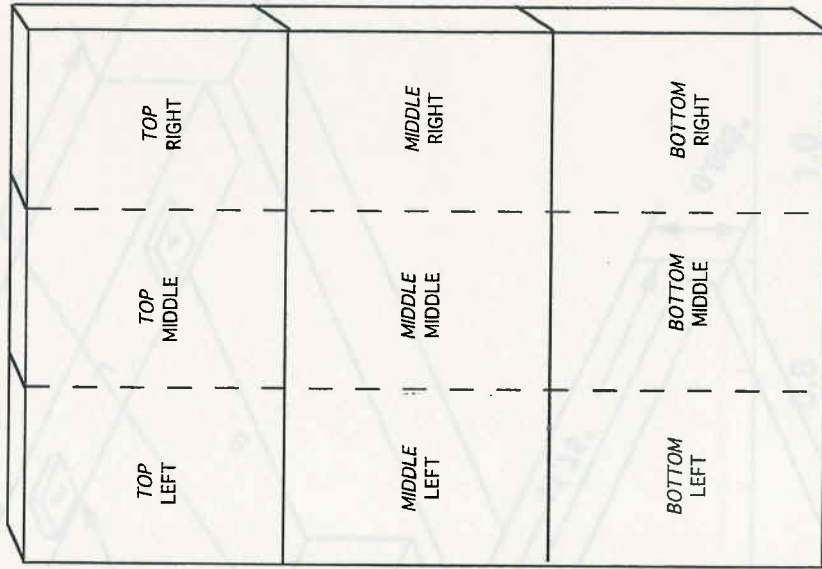
Figure 6. Preform dimensions and coupon locations with respect to tube/panel.

3-D TRIAXIAL BRAID PANEL

The preform was slit axially using the axial fibers as guides. This was done so that no axial fibers would be cut. The preform was then rolled out into a rectangular shape, and baked in an oven for 1 hour at 212°F (100°C) to remove water applied during braiding. The preform was then cut into three 11.5 x 5 inch<sup>2</sup> (292 x 127 mm<sup>2</sup>) rectangles and the braid angle of each panel was measured. Fig. 6 shows the geometry and dimensions of the preform before and after it was slit. This figure also shows the positions of specimens relative to their location in the preform.
