# Characterization of Defects in Low-Cost Resin-Infused Aeronautical Structures

**SUMMARY:** Mechanical tests have shown that vacuum assisted resin transfer molding (VARTM) produces consistent, high quality solid laminates made with E-glass/epoxy vinyl ester. However, these laminates have never been employed in certified aeronautical structures and the process for certification of sandwich structures is even more complex. The objective of this work was to develop an understanding of process-induced defects in E-glass/epoxy vinyl ester sandwich panels with a PVC closed cell foam core, fabricated using VARTM. A variety of non-destructive evaluation (NDE) techniques were used to establish their potential for identifying these defects and to correlate the results with visual observations. It was found that thermography and bondline analysis were effective at detecting and characterizing defects such as dry spots and incomplete resin infiltration. Preliminary evaluations of the flow rate under the influence of processing excursions showed that even a small air leak could increase infiltration time by as much as 25%.

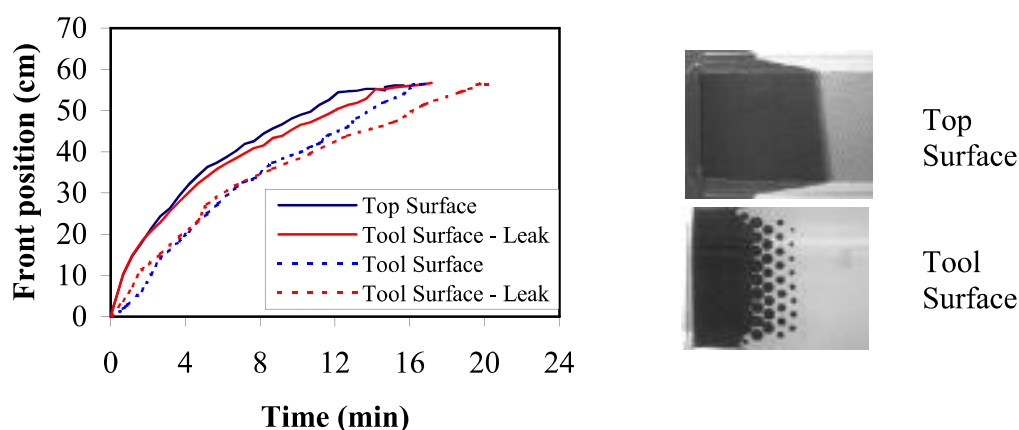
A trial and error approach was used to fabricate specimens containing process-induced defects and resulted in the identification of three types of defects: bubbles, dry spots, and incomplete resin infiltration. Bubbles were categorized as air that infiltrated the resin during infusion because of vacuum bag leakage. Two common sources of leaks appeared to be poor vacuum bag integrity caused by damage or aging, and degradation of the seal between the bag and the tool. These problems were easy to rectify prior to infusion by monitoring the pressure of the bag after the vacuum pump was turned off. The flow disturbances resulting from an undetected leak were analyzed using a flow rate image analysis program and are reported in Fig. 2. It was clear that even a small leak could significantly affect the specimen infiltration time, since the presence of such a leak increased the specimen total infiltration time by 25%, from 16 minutes to 20 minutes.

Fig. 2 Effect of vacuum bag leak on top and tool side flow front position and typical specimen infiltration pattern.
